FULL RESERVE STUDY

Forest Edge Cluster Association, Inc.

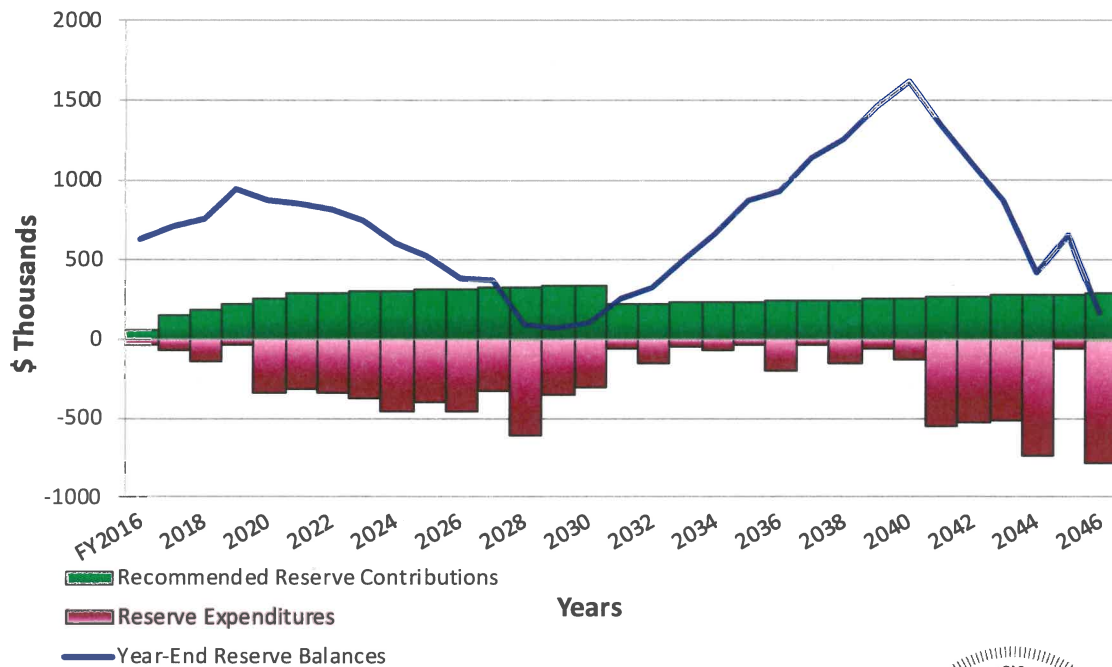
Respectfully submitted on August 15, 2016 by
RESERVE ADVISORS, INC.

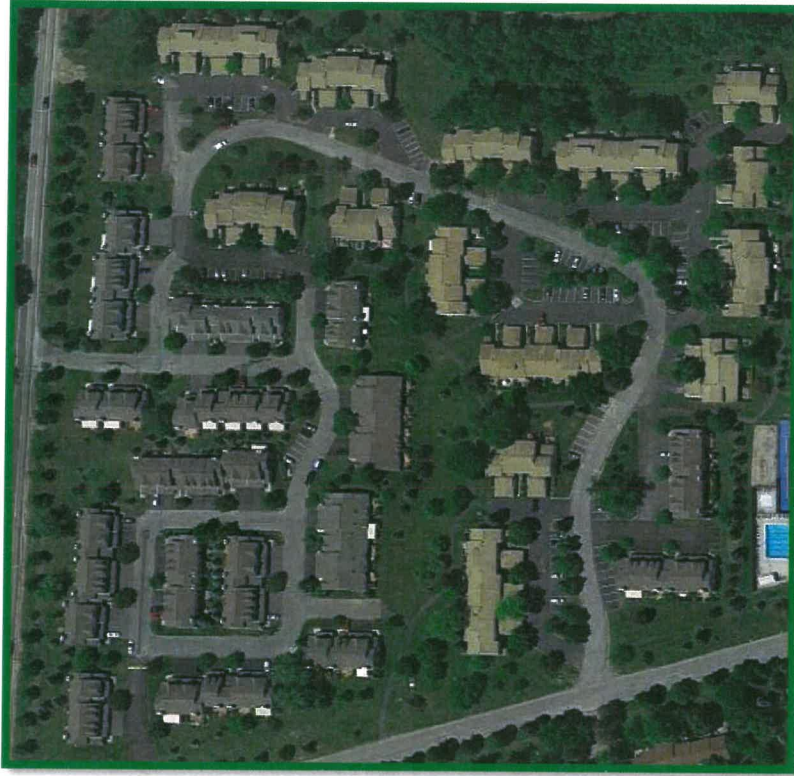
Forest Edge Cluster Association, Inc. is a townhome style development of 155 units in 31 buildings. The east side of the development was built in 1974 and consists of 82 units in 14 buildings. The west side of the development was built from 1989 to 1994 and consists of 73 units in 17 buildings. The exteriors of the buildings comprise vinyl and aluminum siding, masonry veneer and asphalt shingle roofs. The development contains asphalt pavement access drives, an asphalt pavement walking path, concrete flatwork, subsurface utility pipes and vinyl fences. We identify 27 major reserve components that are likely to require capital repair or replacement during the next 30 years.

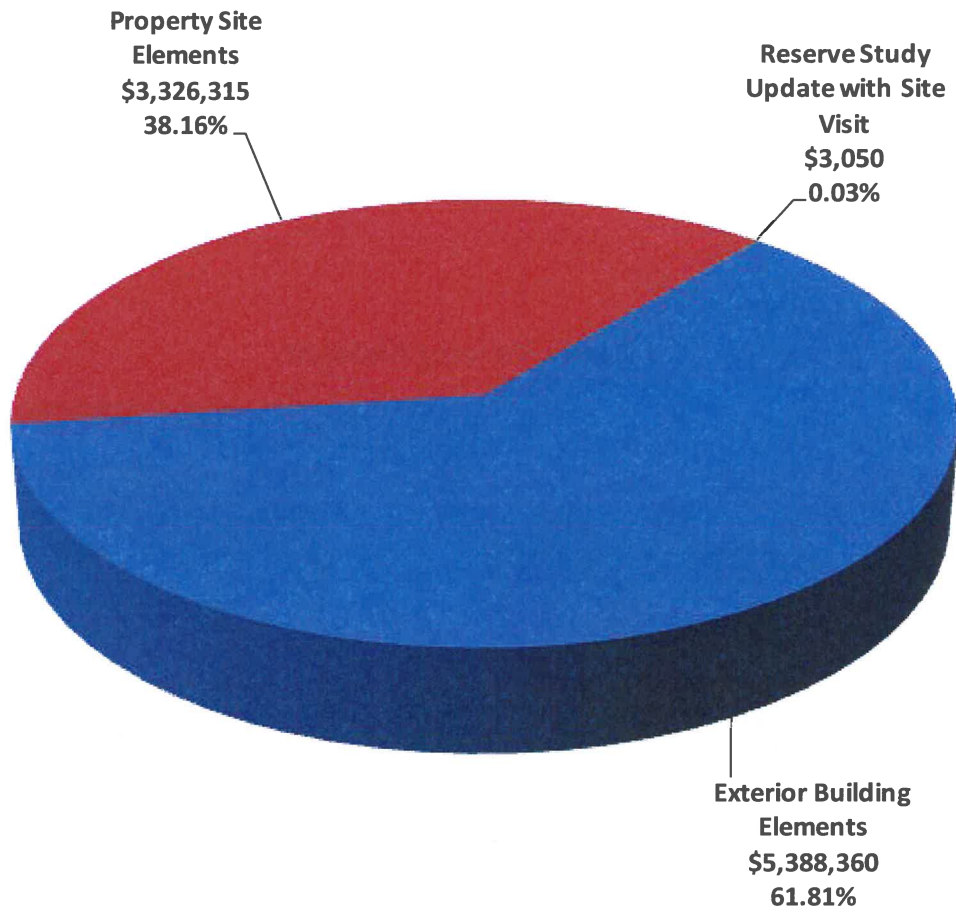
4. CONDITION ASSESSMENT

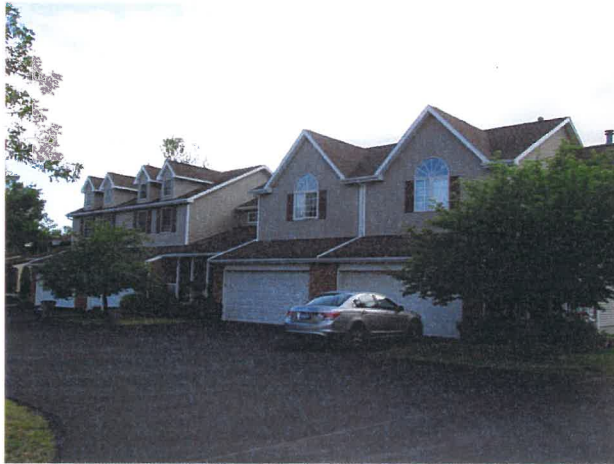
Front building overview, 1989 to 1994 models

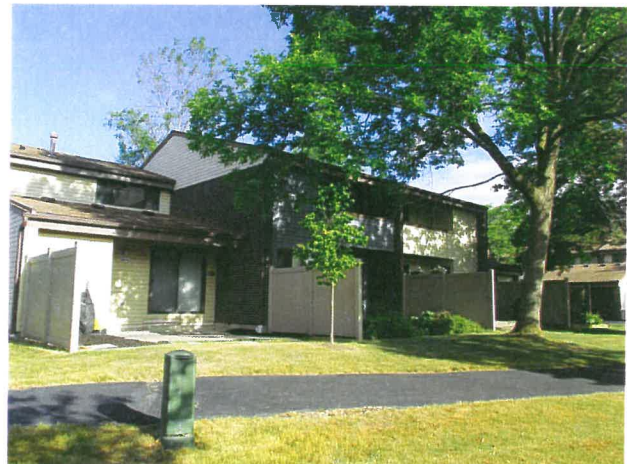
Rear building overview, 1974 models

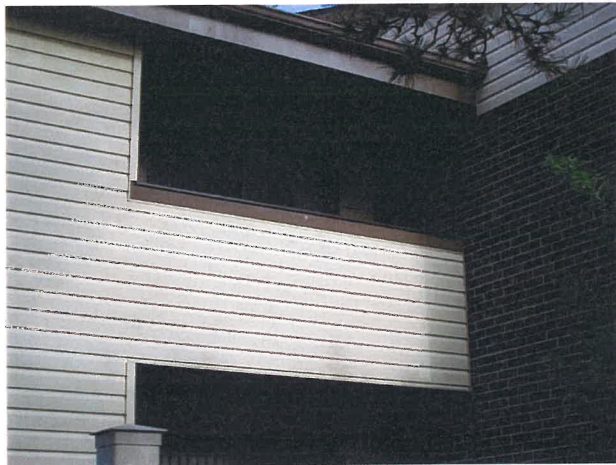
Balconies, Wood - The Association maintains 63 wood balconies which comprise a total of 2,540 square feet. The balconies are in good to fair overall condition at an unknown age. We note partial replacement of balcony decking.

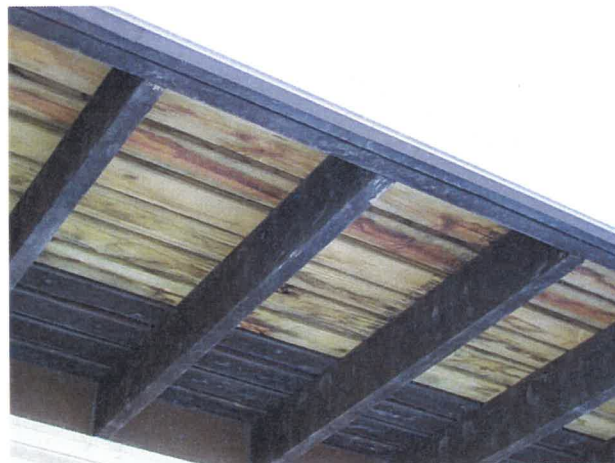
Partial replacement of balcony decking

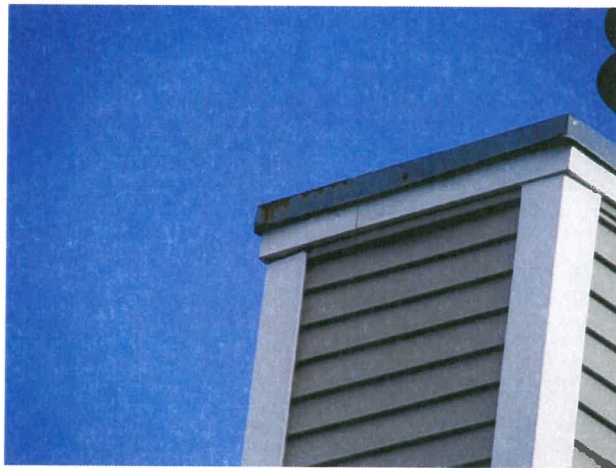
Chimney cap corrosion noted at Unit 1604

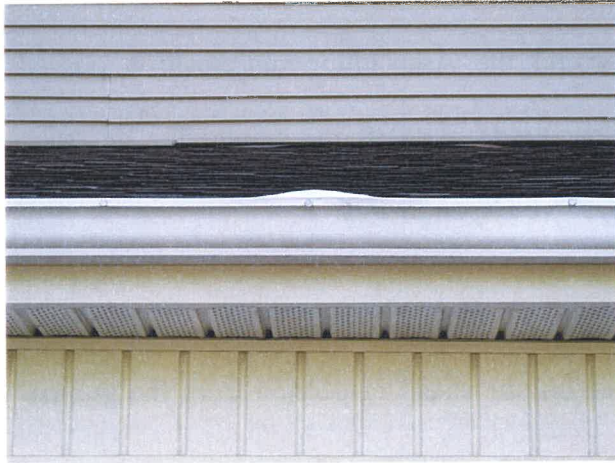
Gutter damage noted at Unit 1601

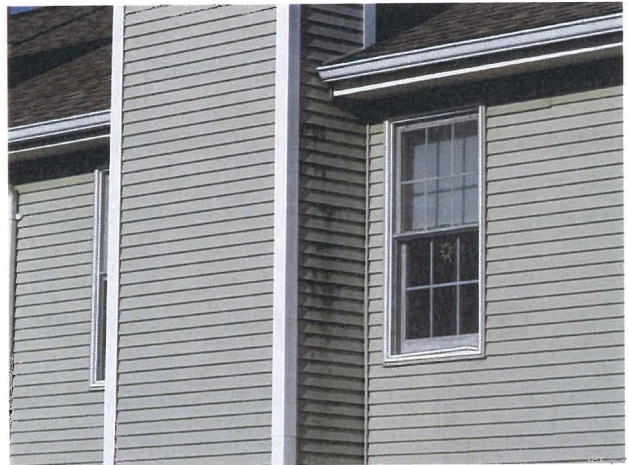
Typical siding stains from gutter overflow

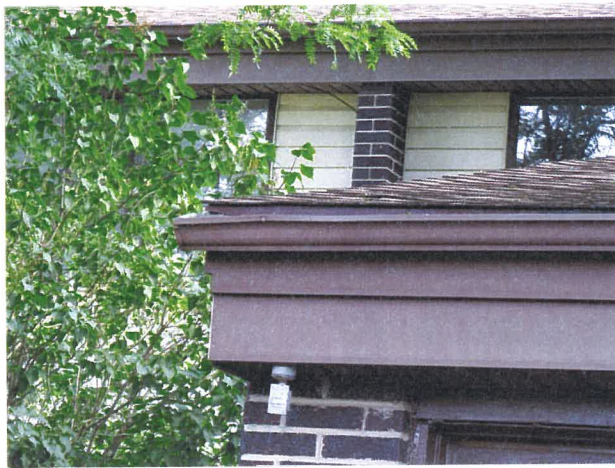
Gutter damage noted at Unit 1004

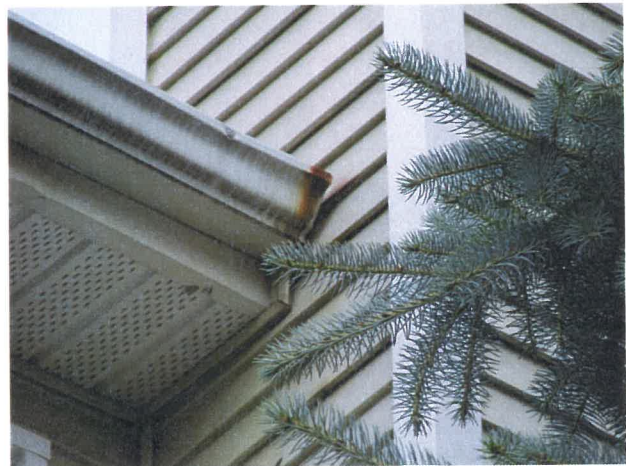
Gutter corrosion noted at Unit 301

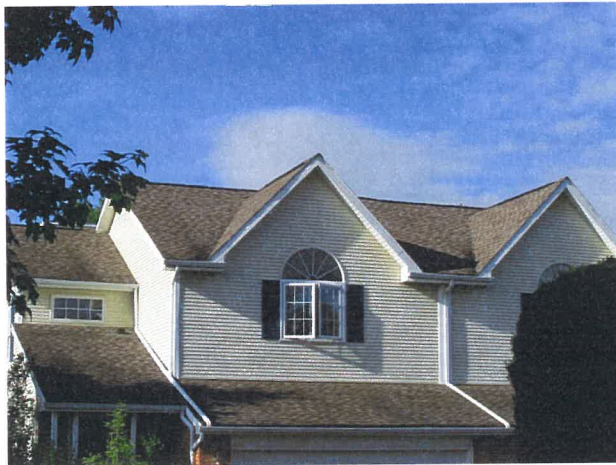
Asphalt shingle roof overview

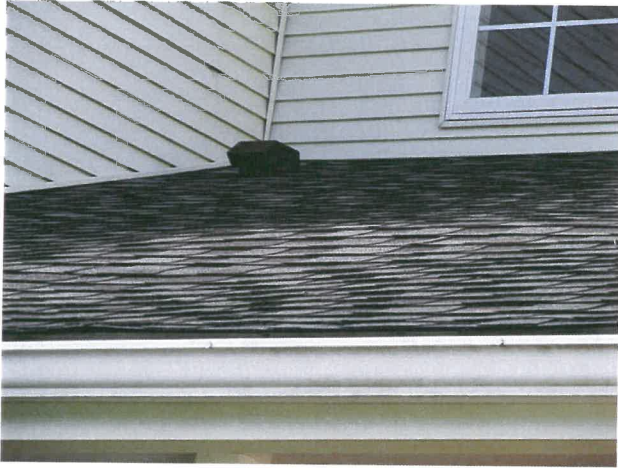
Sheathing deflection noted at Unit 1703

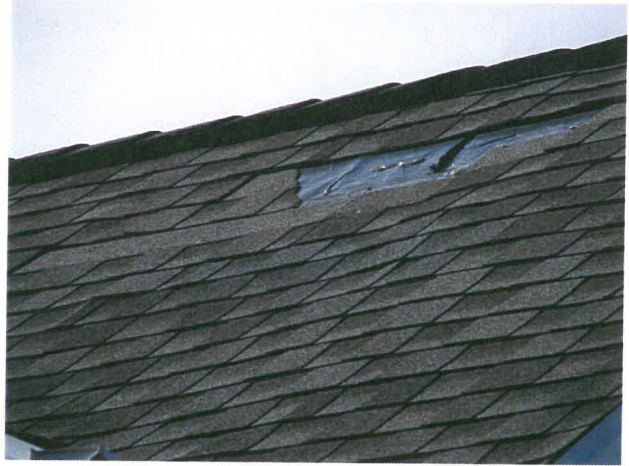
Missing shingles noted at Unit 1603

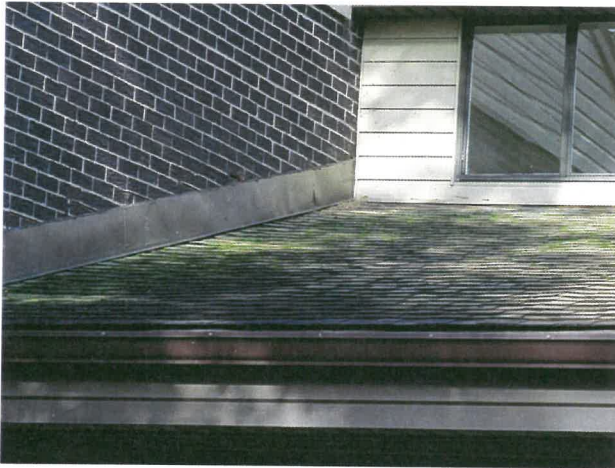
Organic growth noted at Unit 1501

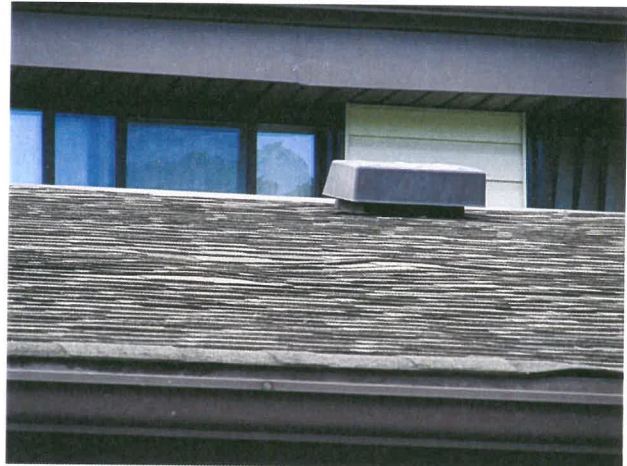
Sheathing deflection noted at Unit 752

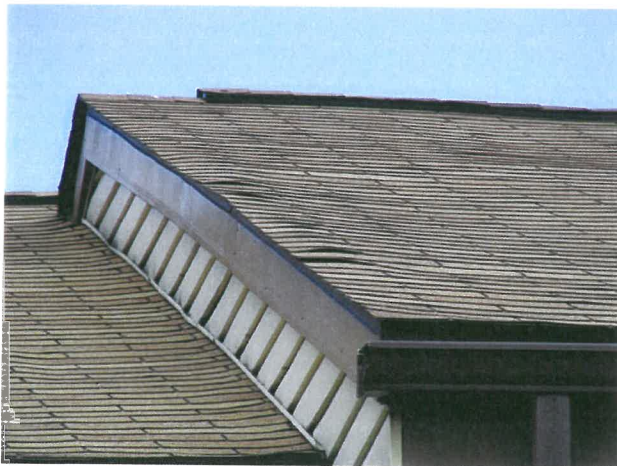
Shingle lift noted at Unit 855

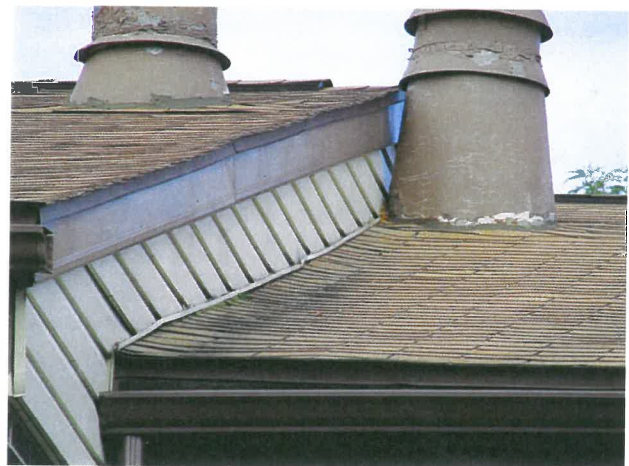
Granular loss noted at Unit 853

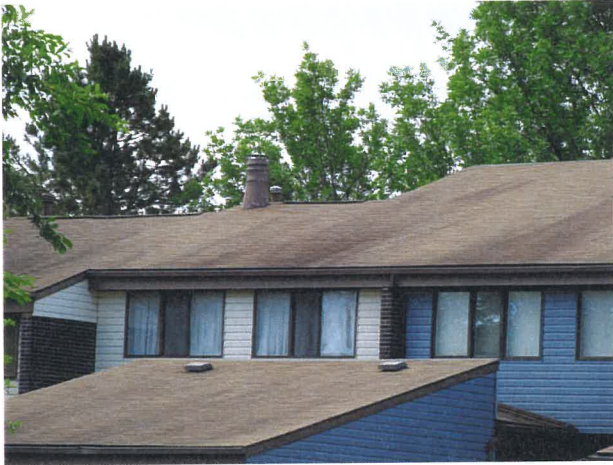
Streaking noted at building containing Units 951 through 958

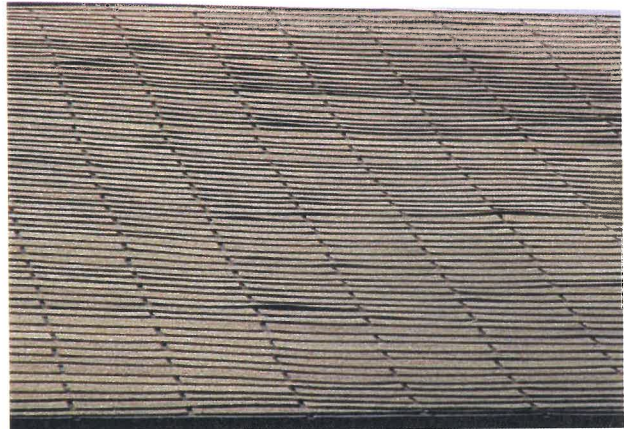
Curled shingles noted at Unit 953

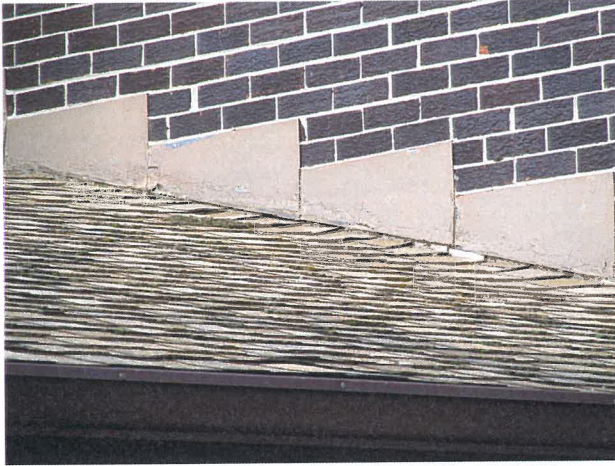
Flashing finish deterioration noted at Unit 1054

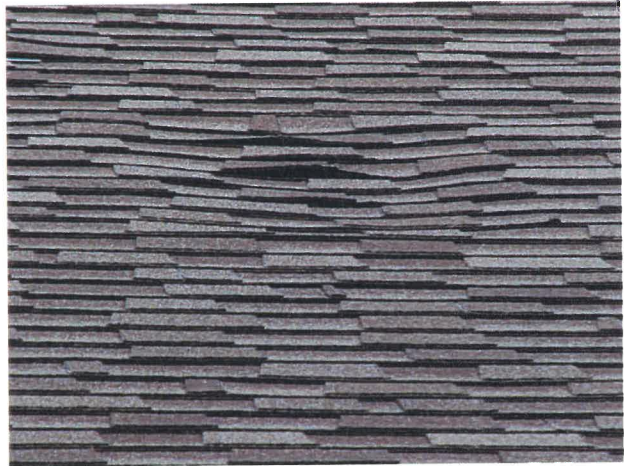
Sheathing deflection and shingle lift noted at Unit 153

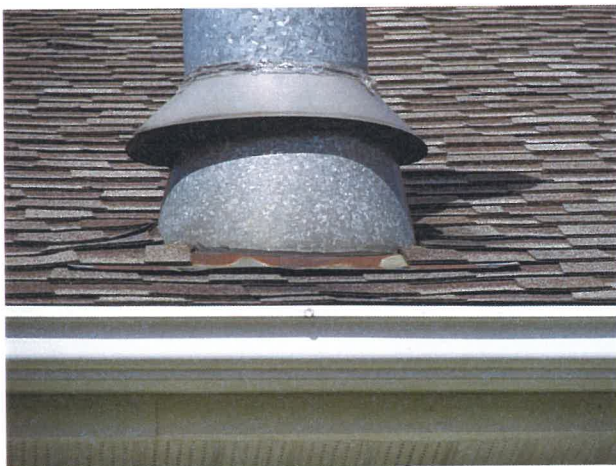
Waste pipe flashing corrosion noted at Unit 453

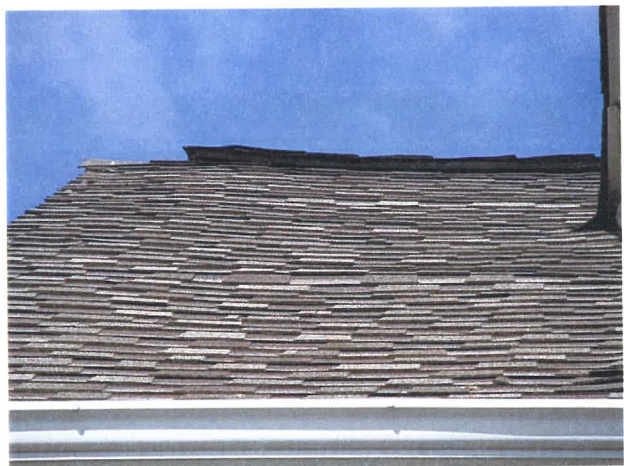
Ridge vent deflection noted at Unit 703

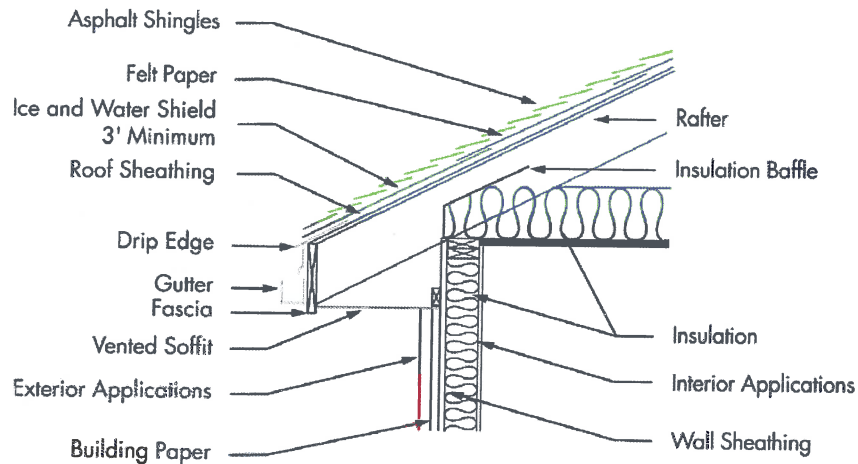
© Reserve Advisors, Inc.

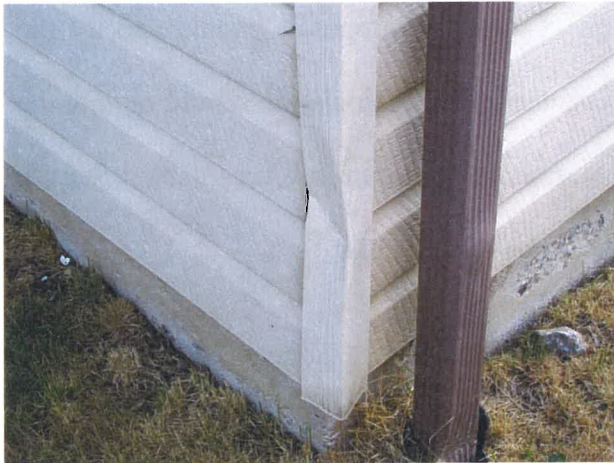
Aluminum trim damage noted at Unit 1406

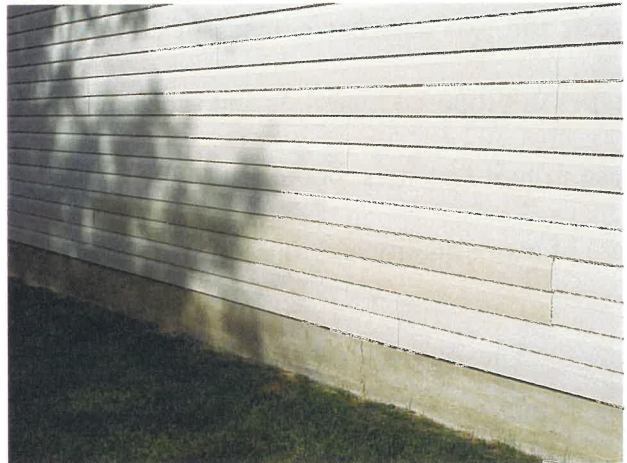
Non-uniform siding color noted at Unit 1108

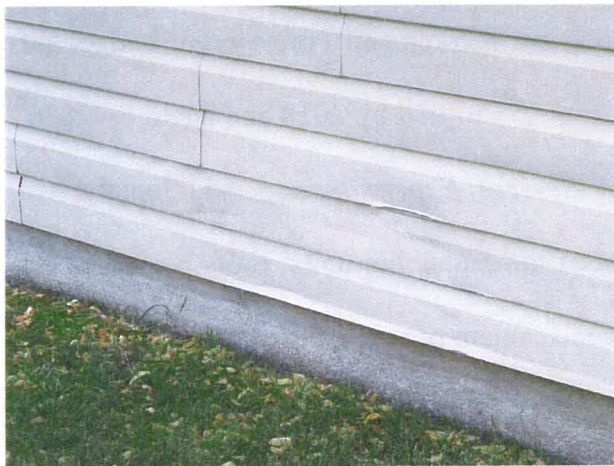
Siding damage noted at Unit 754

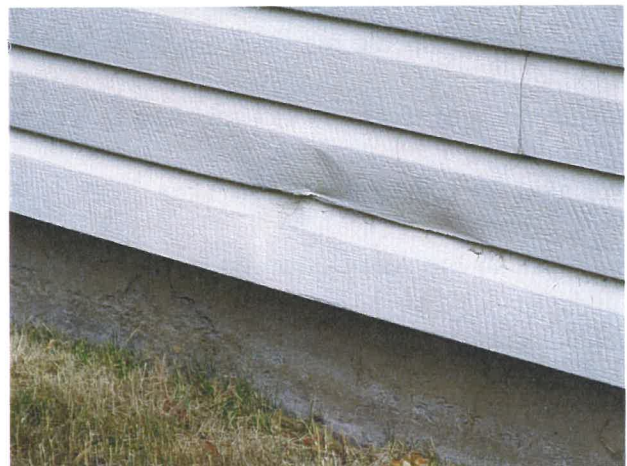
Siding damage noted at Unit 1151

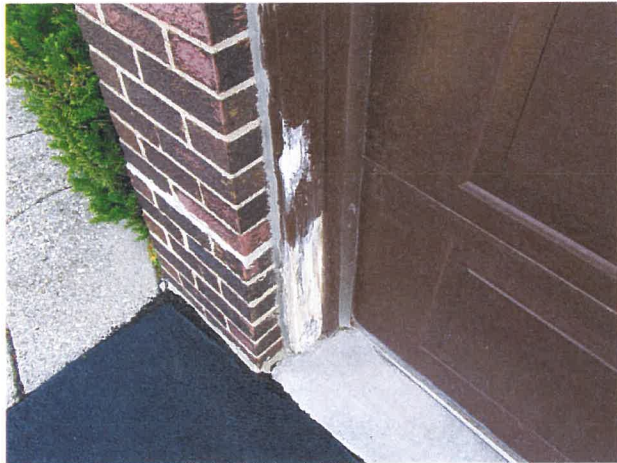
Garage trim paint deterioration noted at Unit 806

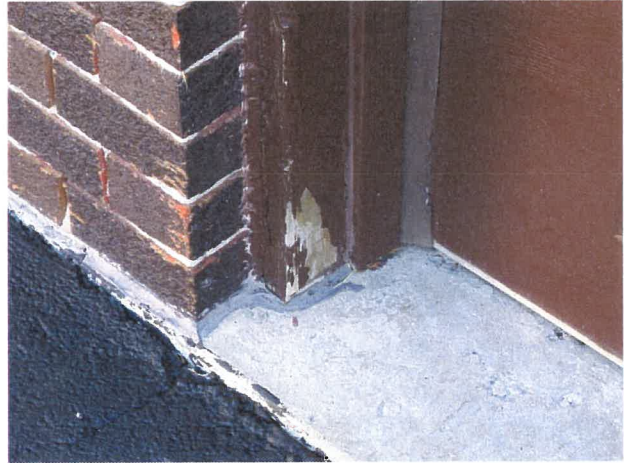
Garage trim paint deterioration noted at Unit 1304

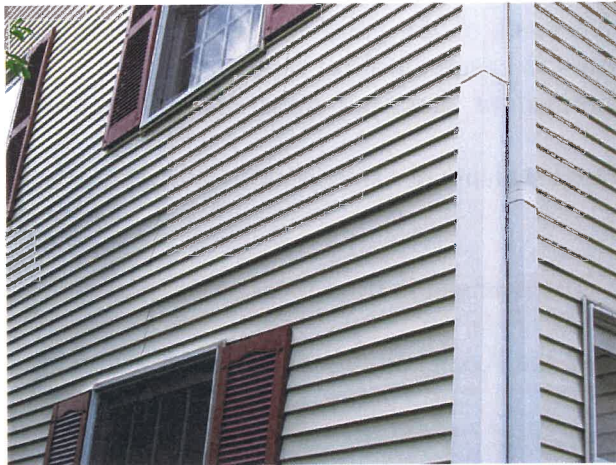
Siding deflection noted at Unit 103

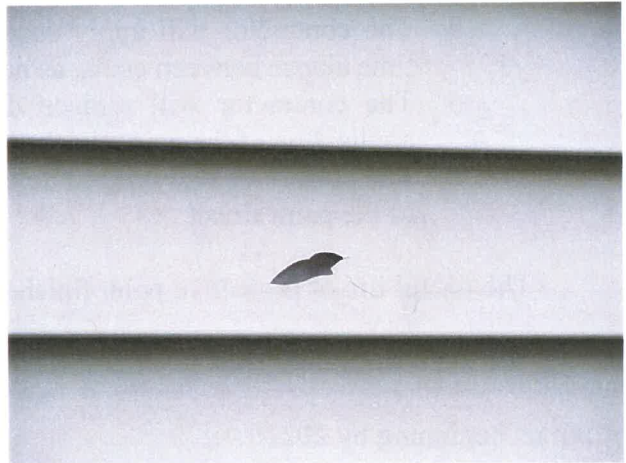
Siding damage noted at Unit 201

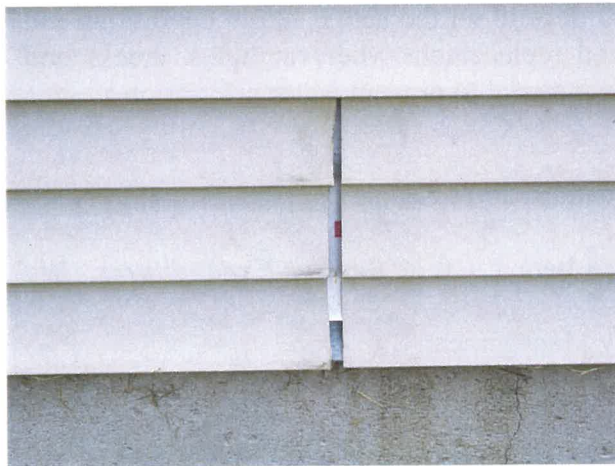
Siding gap noted at Unit 206

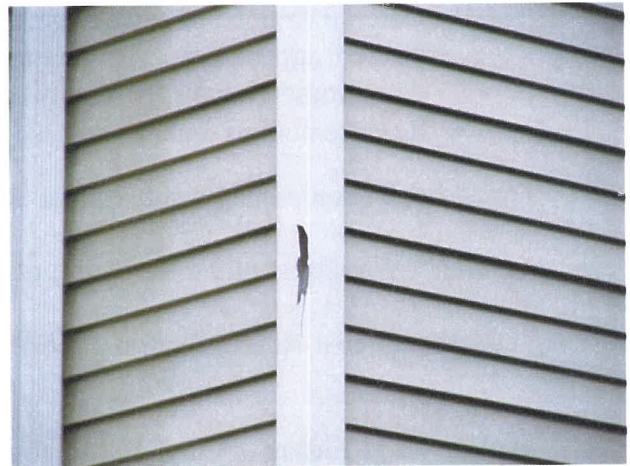
Trim damage noted at Unit 304

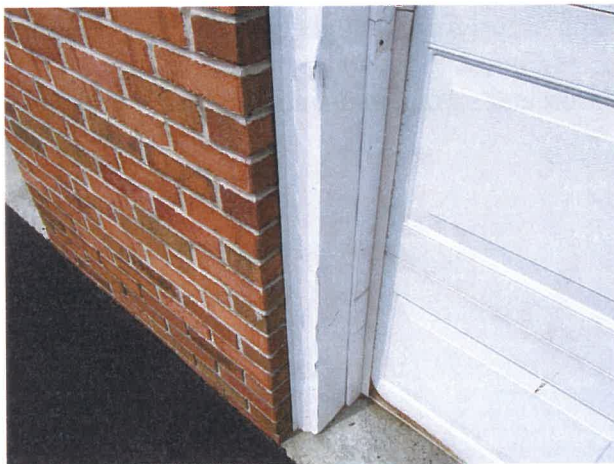
Garage door trim damage noted at Unit 312

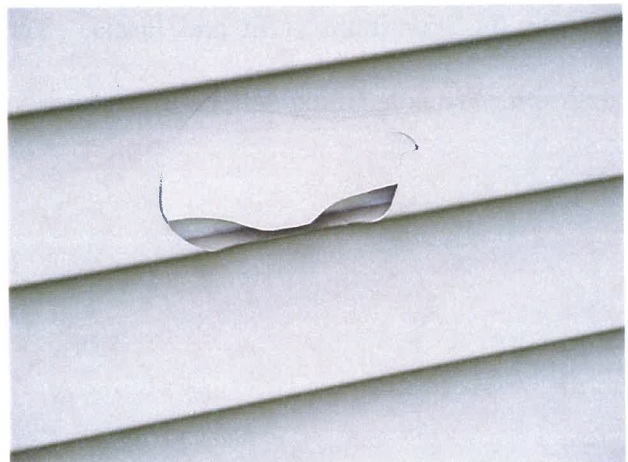
Garage siding damage noted at Unit 454

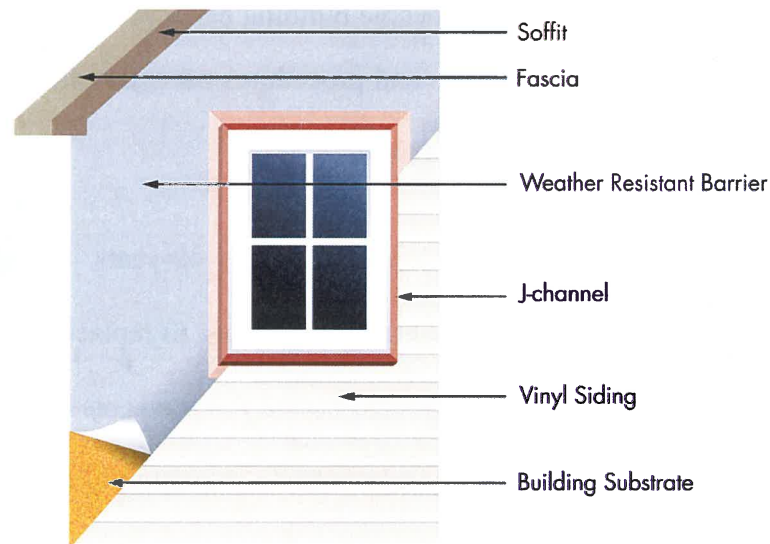
© Reserve Advisors, Inc.

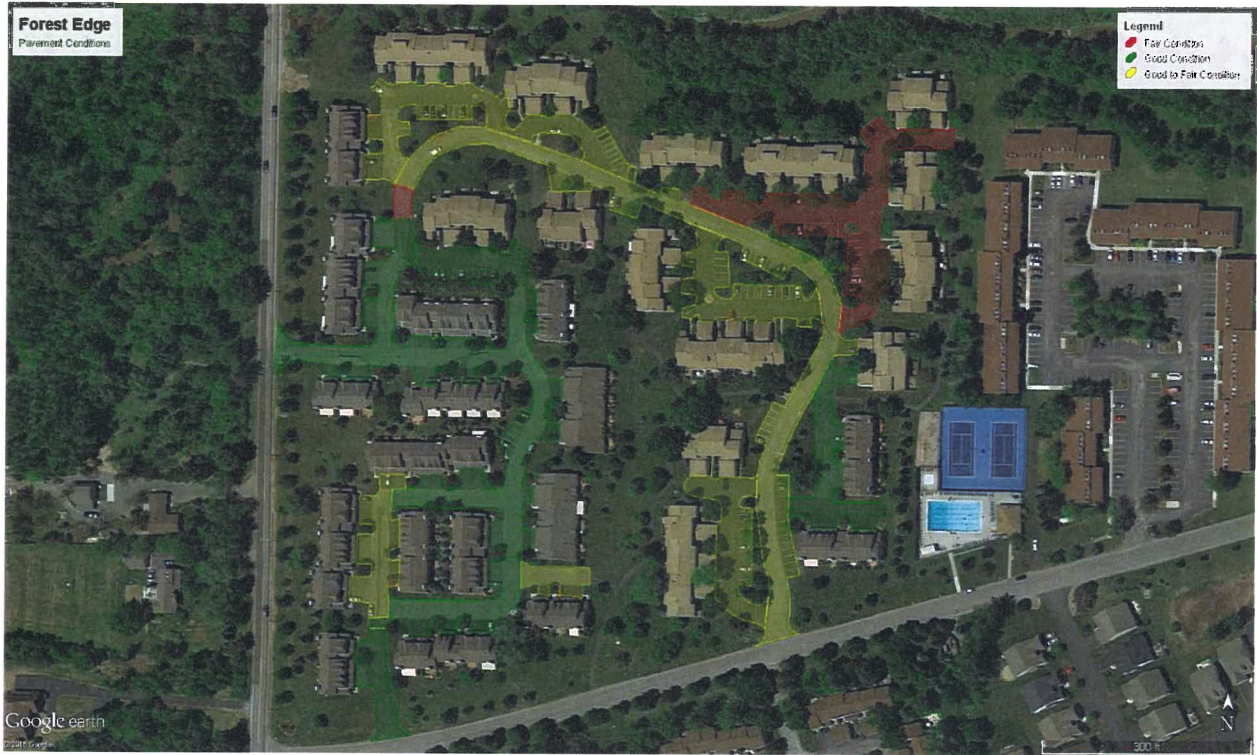
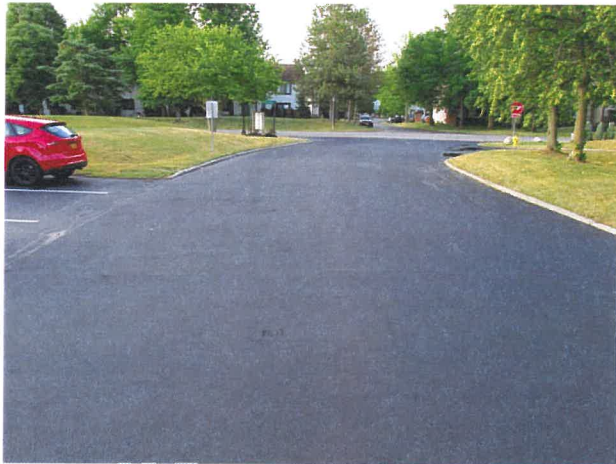
Asphalt pavement overview

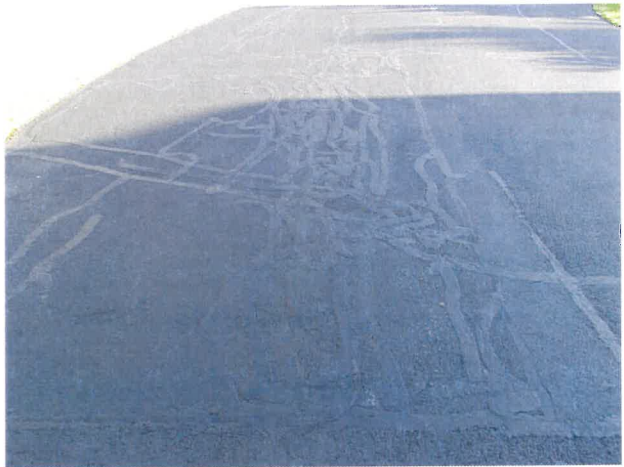
Significant crack repairs

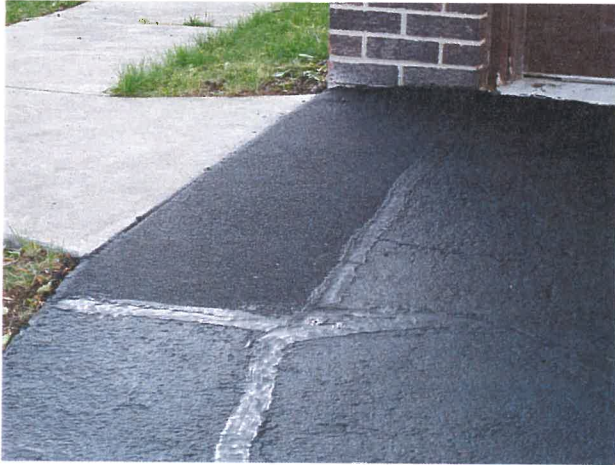
Pavement patch repair

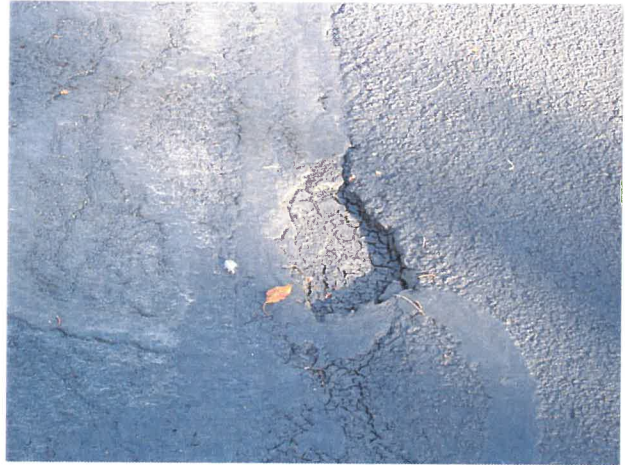
Pavement deterioration

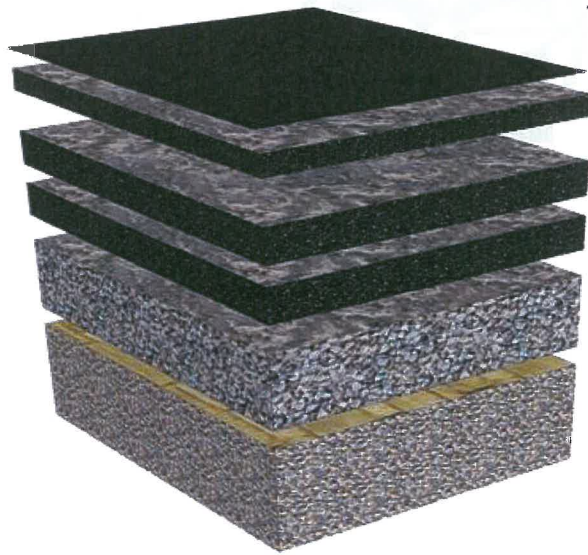
Components of asphalt pavement include native soil, aggregate and asphalt. First the contractor creates a base course of aggregate or crushed stone and native soil. The base course is individually compacted to ninety-five percent (95%) dry density prior to the application of the asphalt. Compaction assures a stable base for the asphalt that reduces the possibility of settlement. For street systems and access drives, the initial installation of asphalt uses at least two lifts, or two separate applications of asphalt, over the base course. The first lift is the binder course. The second lift is the wearing course. The wearing course comprises a finer aggregate for a smoother more watertight finish. The following diagram depicts these components:

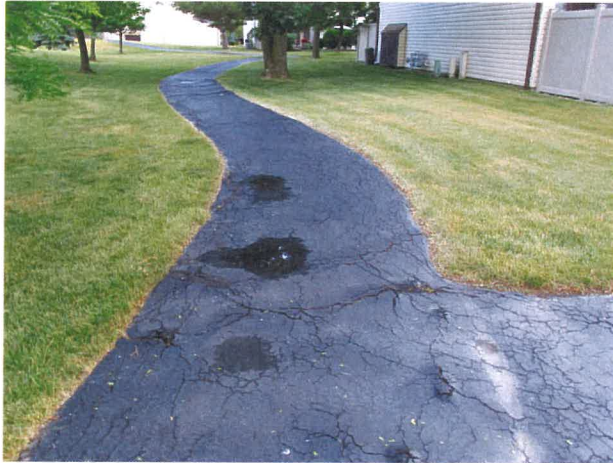
Asphalt pavement walking path overview, note significant cracking

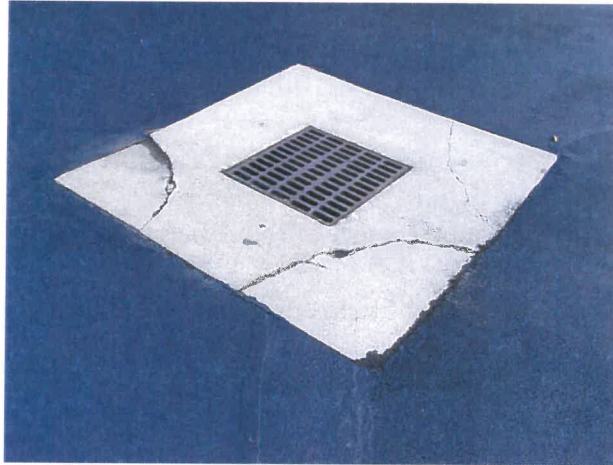
Catch basin overview with cracks in concrete collar

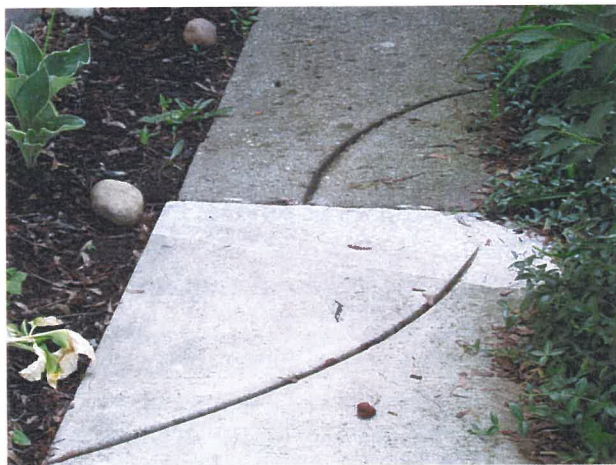
Diamond grinded section of concrete sidewalk

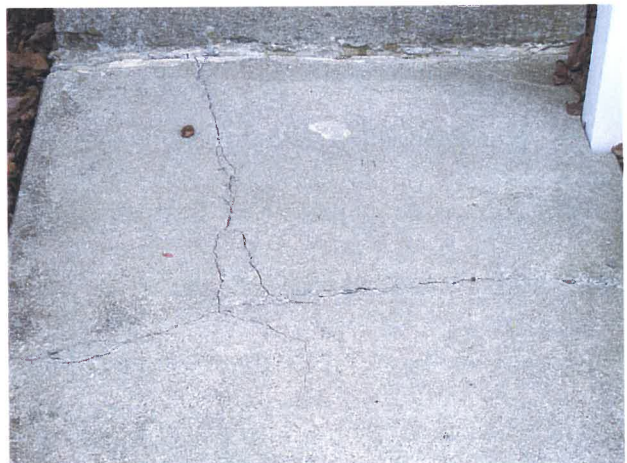
Concrete sidewalk cracks

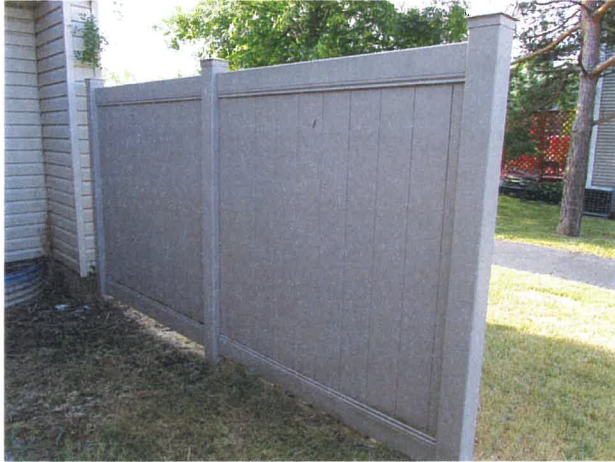
Vinyl fence overview

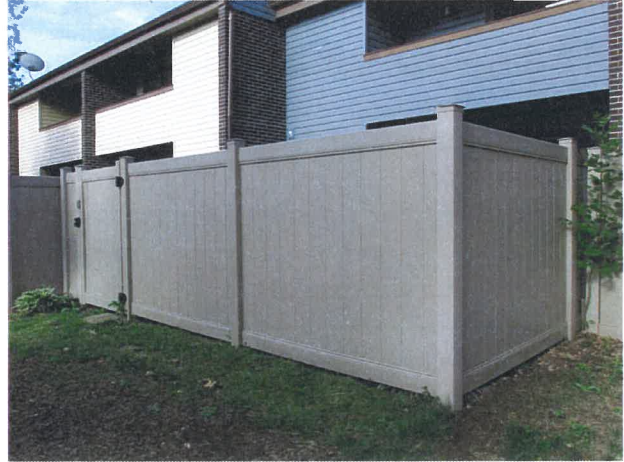
Vinyl fence overview

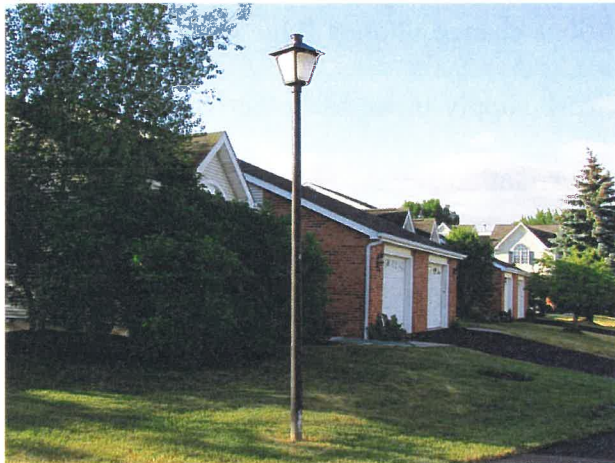
Light pole and fixture overview

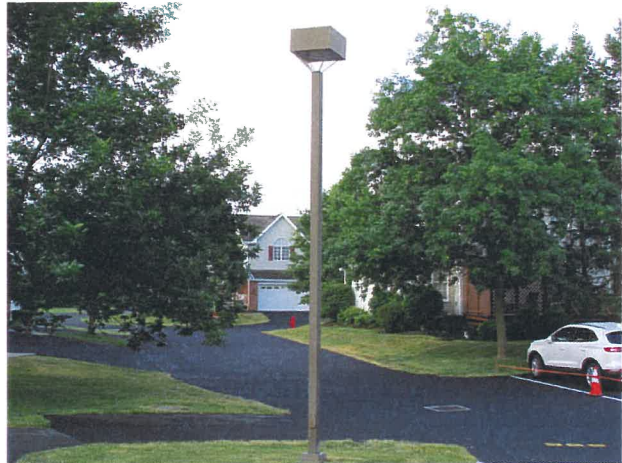
Light pole and fixture overview

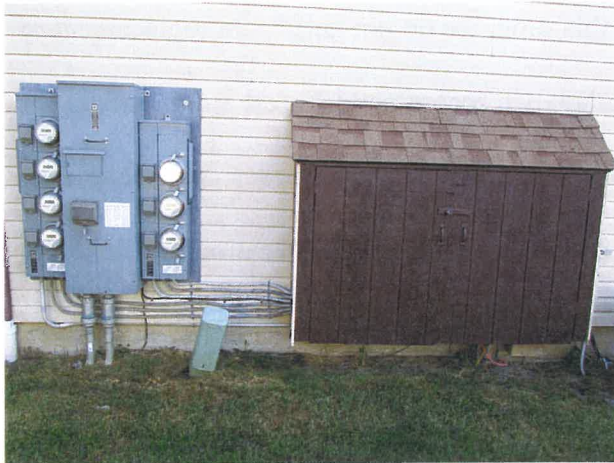
Utilities, Electrical, Junction Boxes - Forest Edge maintains the 14 electrical junction boxes at the east development. Management informs us the Association has replaced two of the junction boxes. The remaining 12 electrical junction boxes are original and in operational condition.

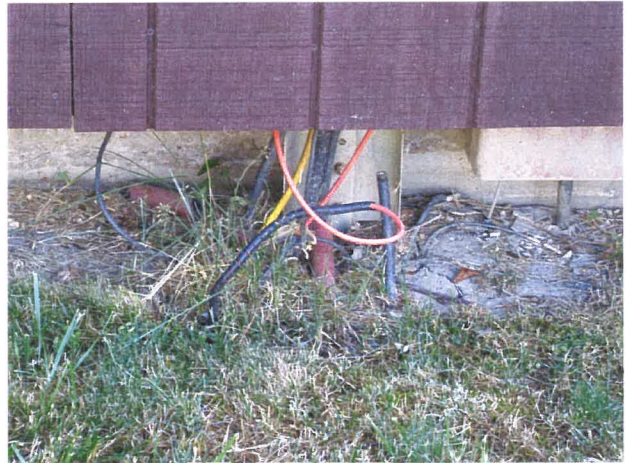
Ground connections severed from soil movement

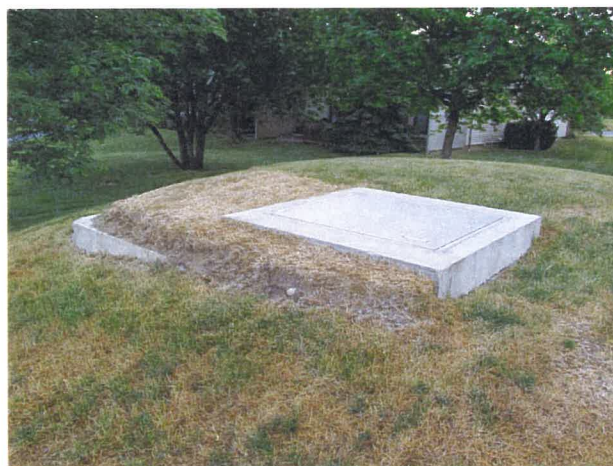
Water main backflow prevention valve structure
